CONTRACTOR REPORT ARLCD-CR-80013

EVALUATION OF SMALL ARMS PROPELLANTS IN LOADING HOPPER

SOUTHWEST RESEARCH INSTITUTE
6220 CULEBRA ROAD
SAN ANTONIO, TEXAS 78284

AUGUST 1980

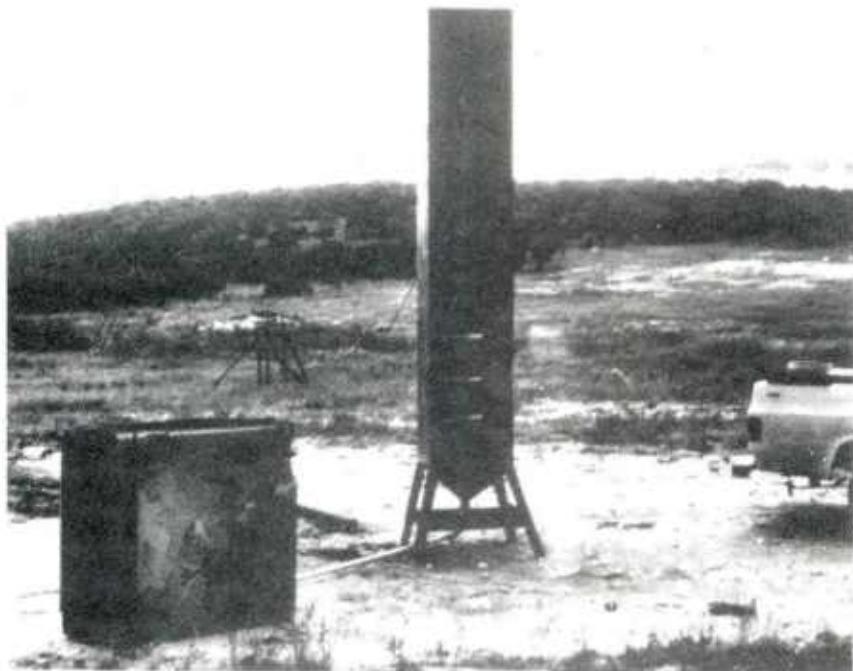
Figure 5. Typical temperature recording locations

Temperatures were measured by the use of Teletemp Temperature Recorders Model 110, purchased from Teletemp Corporation, Fullerton, California. Teletemp strips were pasted to the outside of the hopper at locations of 305, 610 and 914 mm above the conic base of hopper (fig. 5). When attempts were made to monitor the hopper temperature at or below the propellant height, the temperatures exceeded 260°C (the maximum temperature of the recorders used).

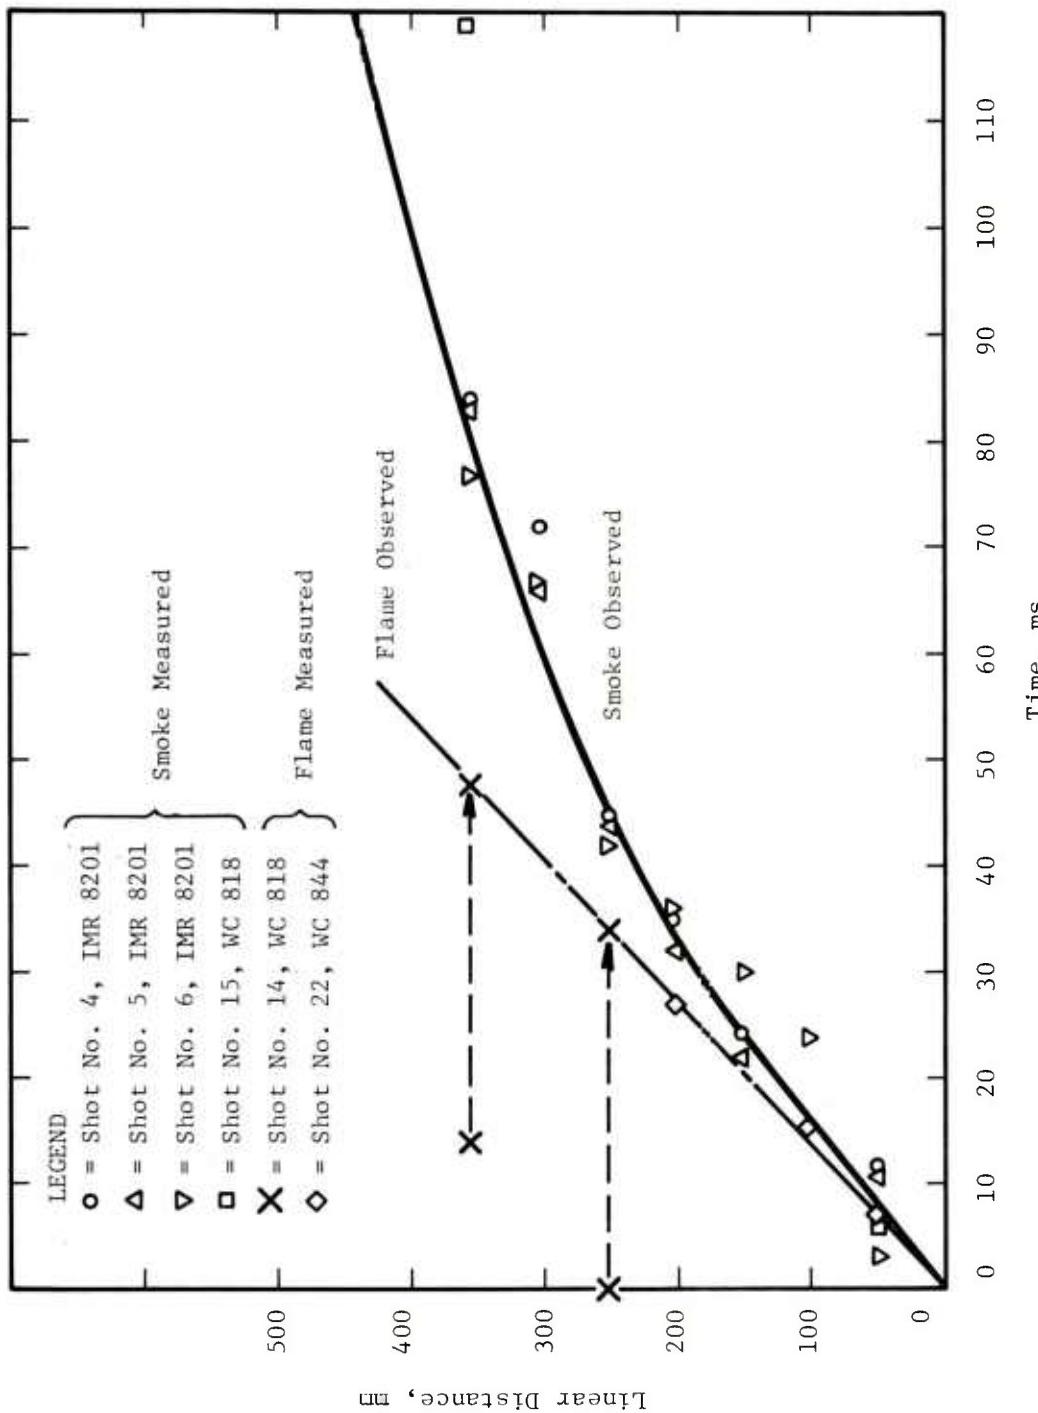
Figure 6. Apparent burning distance versus time

An observable difference was expected in the flame spread, or apparent burning distance, measured for the three propellants. This difference, however, was not apparent in the data recorded. An inspection of the Hycam film records indicated that, for the most part, smoke obscured the fire of the burning propellant as viewed through the holes in the hopper base. However, the smoke emission formed a hole-to-hole sequence that was measurable. The Hycam records were reduced and the linear distance of the smoke emission sequence was plotted against time. These data are shown in figure 6. On two test records flame could be seen through some of the holes. The "flame distance" was also plotted (fig. 6). The straight line, which is the upper plot, illustrates the flame linear distance-time relationship. The lower line illustrates the smoke distance-time relationship. In addition:

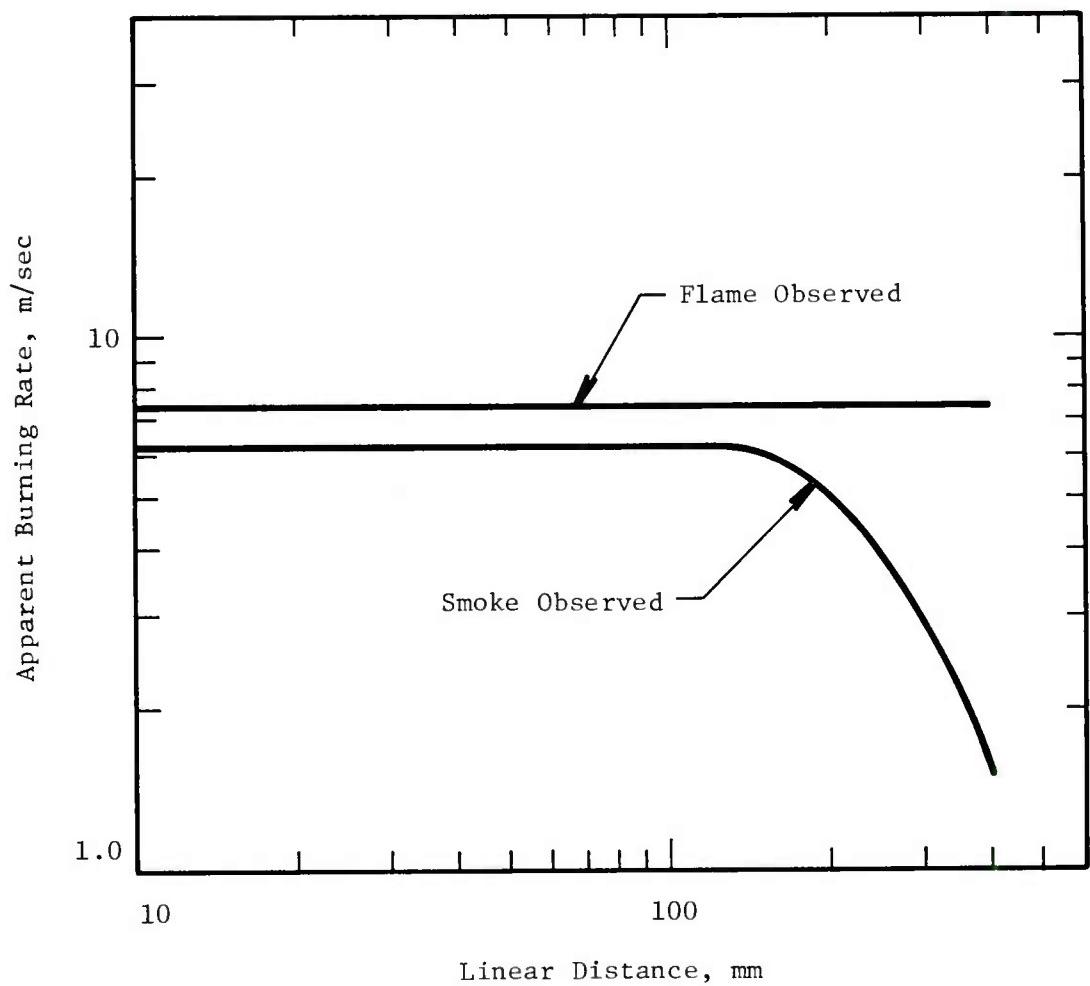
Figure 7. Apparent burning rate vs linear distance burnt fire in hopper, bottom ignition

If the curves in figure 6 are differentiated, the apparent burning rates are determined. These relationships are shown in figure 7. The flame spread rate (upper curve) is about 7.4 m/sec. The apparent burning rate observed for the smoke is somewhat less, 6.2 m/sec, but this represents only an approximately 16% difference from that of the flame observed rate and tends to confirm the general magnitude of the flame spread rate within the hopper.

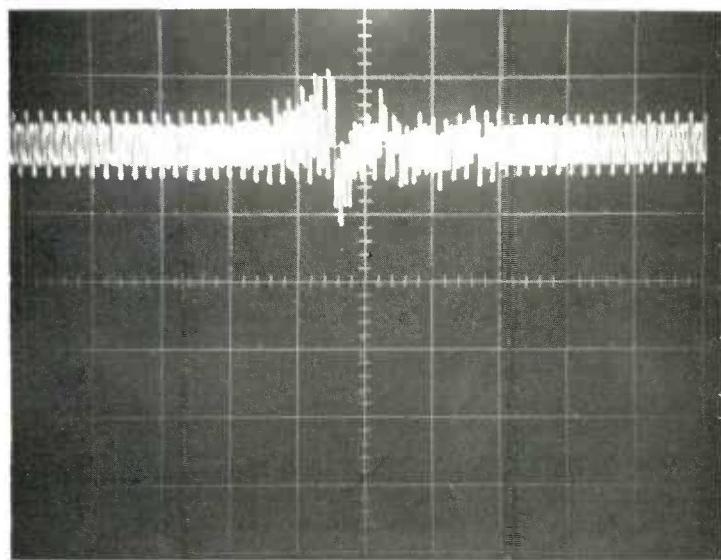
Figure 8. Typical hopper pressure record for IMR 8208 propellant

The first test and test series were conducted with IMR 8208 propellant. Since IMR 8208 has the lowest burning rate of the three propellants investigated, it was assumed that would be the least likely to cause hopper overpressure. This assumption was verified on the basis of the tests. The burn was relatively quiet and the peak pressure measured was consistently at 3.4 kPa for the six tests in which measurements were taken. The low gauge sensitivity resulted in a noisy pressure record, which was inadequate. A typical pressure-time record is shown in figure 8. In this record of test no. 8, each vertical division represents 5.58 kPa and each horizontal division represents 250 ms. In each of the pressure records a double pressure pulse is indicated, with the second pulse being the highest. This could indicate that the burning reaction causes propellant grains to be ejected up into the hopper stack where they are ignited. The greater propellant surface area of this action could cause the higher pressure of the second pulse. Figure 9 shows the pressure gauge location of the hopper. The gauge is located immediately to the left of the loading port. A garden hose was used to shield the gauge cable from the fire.

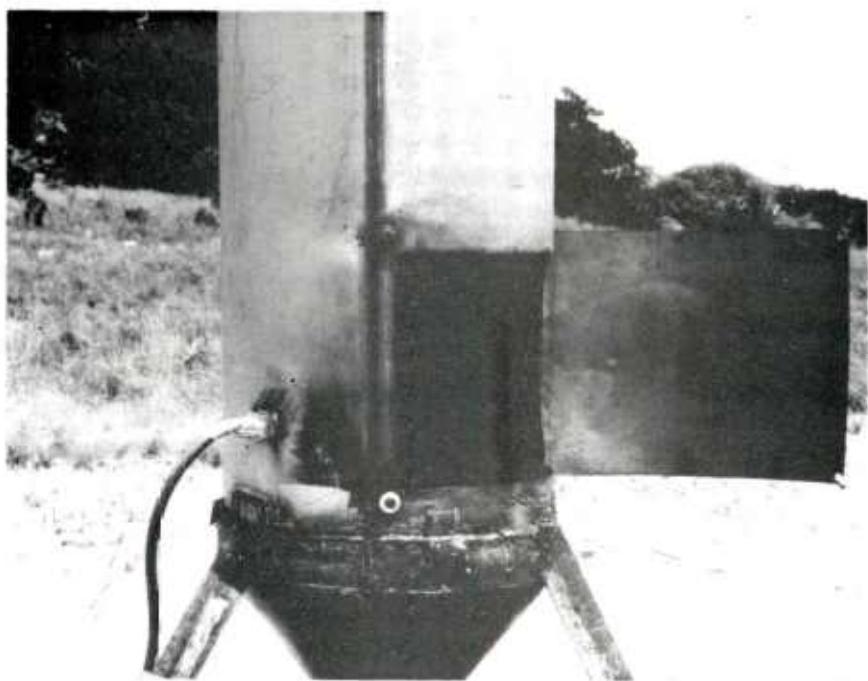
In several of the tests, the loading port blew open either by shearing the door material at the attach points or by stripping the bolts. One such incidence is shown in figure 10. Subsequently, a stronger port was used. There was no perceptible difference in the hopper pressure-time records between the two ports.

Figure 10. Loading port open after test with IMR 8208 propellant

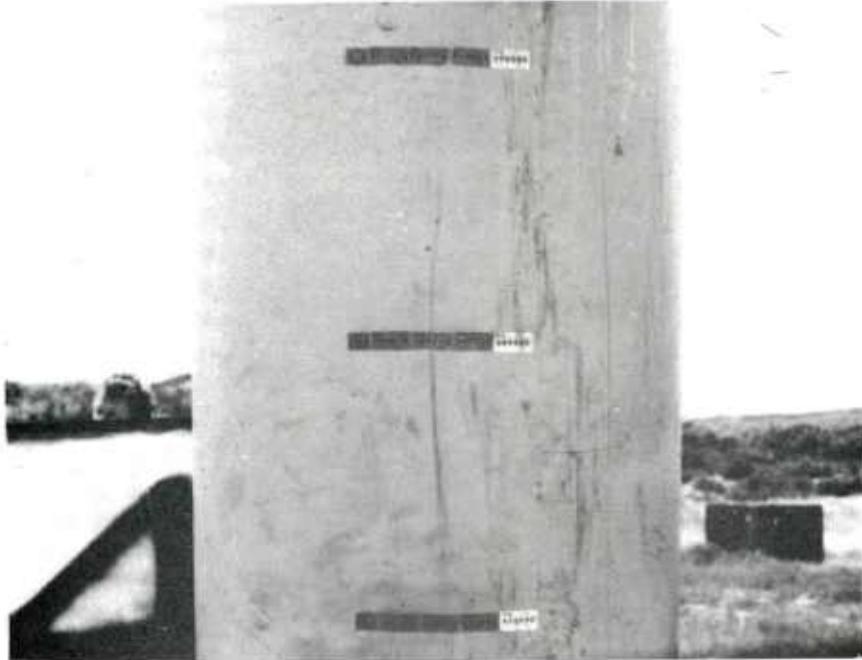
Figure 11 shows the teletemp locations used on the conventional hopper. As with the pressure records, the temperature records

indicated a reproducibility of temperature distribution from test to test. The temperature gradient was slight (table 1), indicating about a 3°C gradient in about 1 m along the hopper stack. Temperature measurements taken below the propellant level on the hopper, indicated temperatures of 260°C or greater.

Figure 11. Teletemp locations on the conventional hopper, after a test

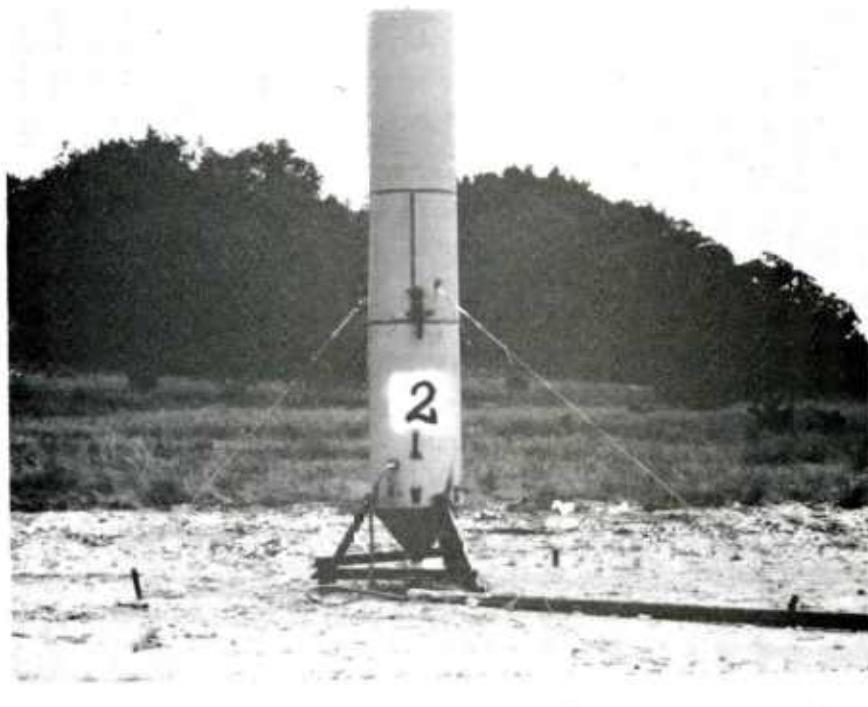
The test series with WC 818 propellant was expected to produce higher reactions within the hopper than the IMR propellant. Indeed, in the initial exploratory tests, a test with WC 818 damaged the hopper so severely that a new hopper had to be made. The initial hopper configuration (before the test) is shown in figure 14. The hopper damage (fig. 15) was confined, primarily, to the hopper-stack junction. This damage was caused by the two-body action of the hopper and the sack during the propellant burning process which was compounded by the constraints placed by the guy wires used to support the hopper.

Figure 14. Initial conventional hopper prior to test with WC 818 propellant

Figure 15. Initial conventional hopper after test with WC 818 propellant

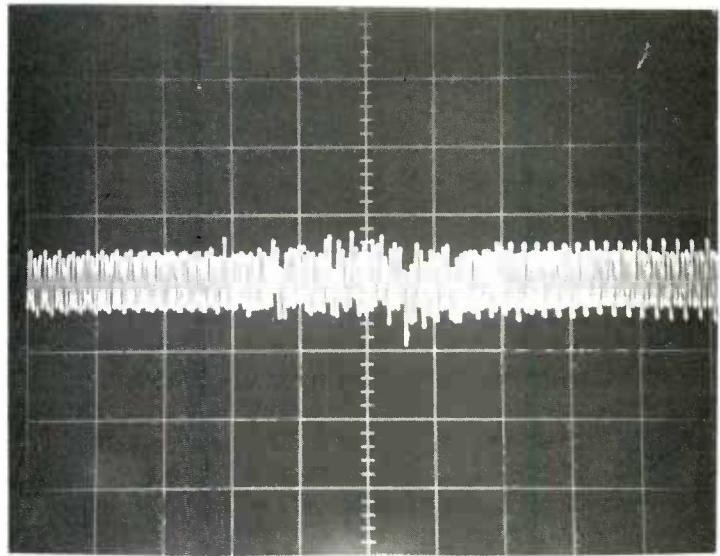
Figure 16. Typical hopper pressure record for WC 818 propellant

for WC 818 propellant is shown in figure 16. Each vertical division represents 5.58 kPa and each horizontal division represents 250 ms.

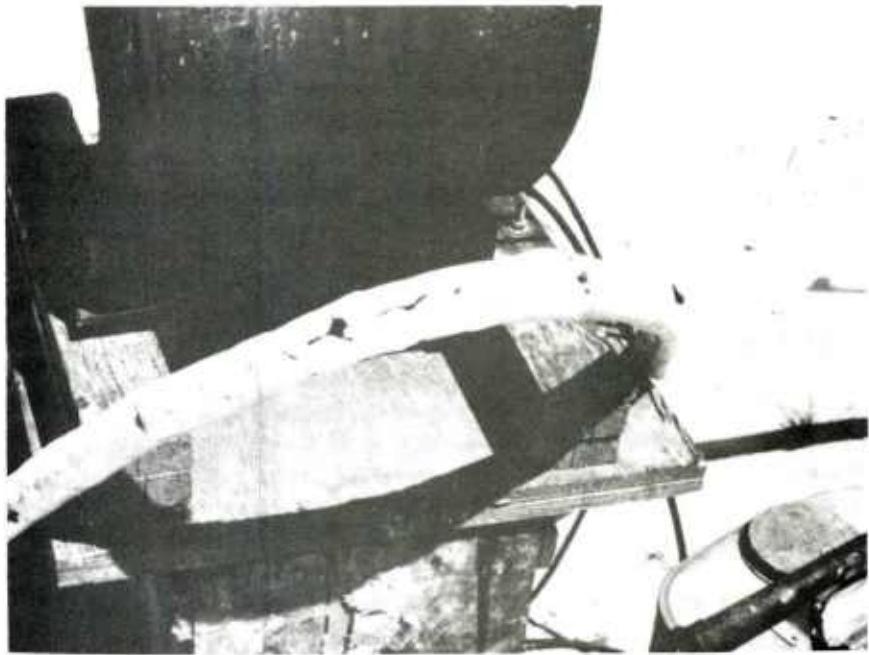
The feed pipe is a hazard source with WC 818 propellant, as it is with IMR 8208 propellant. The frequency of occurrence, however, appears to be lower for the WC 818 propellant. Of four tests with the steel feed pipe, one exhibited the explosive reaction (or possibly a detonation) of the propellant within the pipe. The explosive reaction took place 305 mm from the discharge end of the pipe. As before, the fragments were relatively large and were ejected over a wide area. The feed pipe was propelled about 10 m from its original location. Five tests were conducted using a PVC feed pipe. No explosions were encountered. **Each of the pipes burned through and were distorted by the heat.** A typical PVC pipe, after the test, is shown in figure 17.

Figure 17. Typical PVC feed pipe after WC 818 propellant test

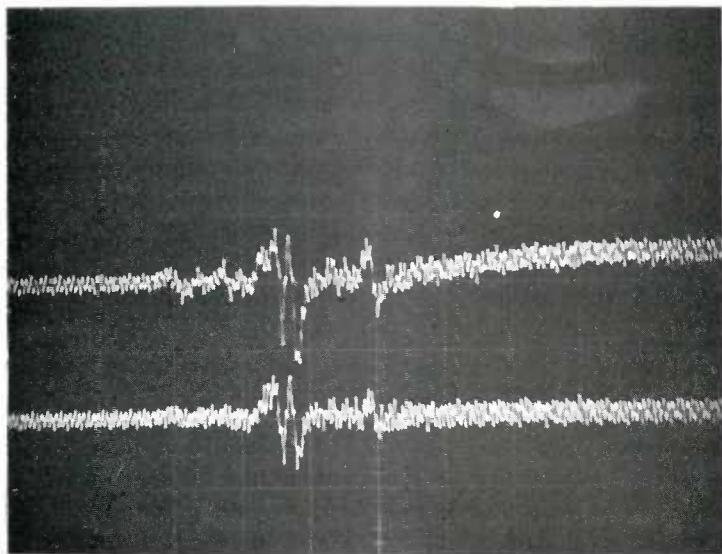
Figure 18. Pressure traces from SCAMP hopper with 45 kg of WC 844 propellant

Ten tests were conducted with 45 kg of WC 844 propellant in the SCAMP hopper without an overpressure incident. Typical temperature levels at the 305, 610, and 914 mm temperature positions were 152°, 138° and 127°C, respectively. Test-to-test variations of about 27°C were encountered. The temperature readings for the WC 844 propellant were significantly below those of the IMR 8208 and WC 818 propellants. Peak pressures were typically in the order of 4.8 kPa. This value is slightly higher than that experienced with the other two propellants. The WC 844 propellant burned with audible pulsations. These pulsations are reflected in the pressure traces. A typical pressure trace is shown in figure 18. Two traces are shown. The upper pressure trace is from a gauge mounted midway up the stack. Each vertical division represents 10.07 kPa for the upper trace and 9.24 kPa for the lower trace. Each horizontal division is 250 ms. The upper gauge was added after it appeared that secondary reactions may be taking place near the middle of the stack. This is discussed further below.

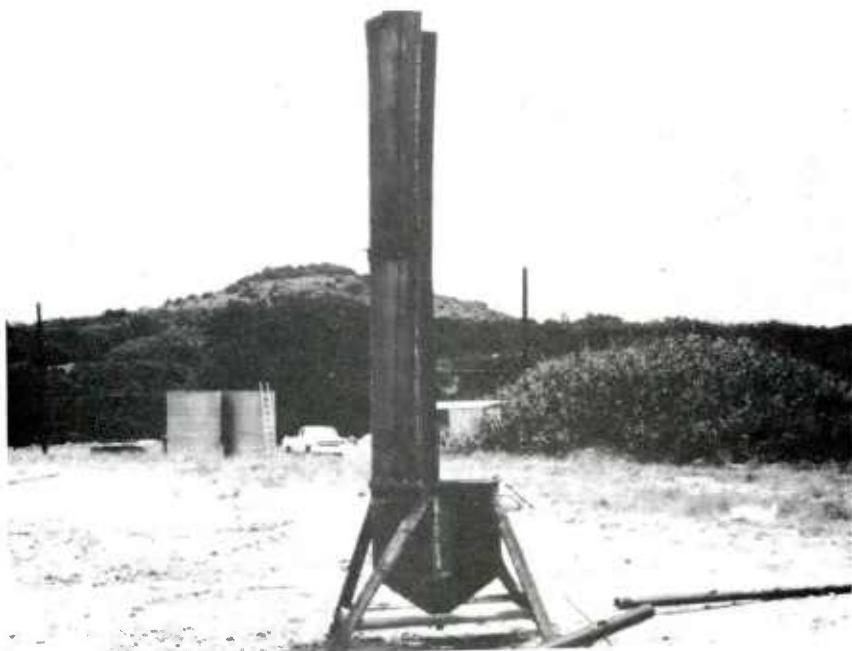
The SCAMP hopper propellant load was initially specified at 91 kg. That charge was placed into the hopper and initiated (figs. 19 through 23). Side panels of the hopper were separated from the hopper and blown a distance of about 9 m. The damage necessitated the fabrication of another hopper. The shape of the side panel (fig. 22) indicated that a secondary reaction, located about half-way up the stack, may have caused the hopper explosion.

Figure 19. SCAMP hopper after 9 $\frac{1}{2}$ kg of WC 844 propellant were initiated in hopper

1. The maximum height of the WC 844 propellant within the SCAMP hopper be reduced from its present in-process height of 546 mm to 346 mm; this corresponds to a change in the propellant weight from its present in-process weight of 91 kg to 45 kg.

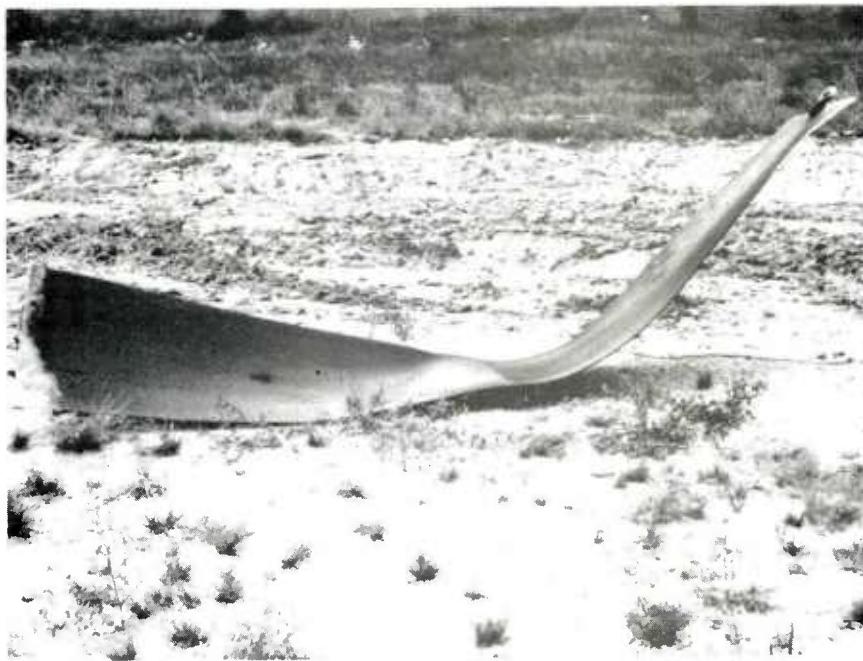
8. The vent pipe, as installed in these tests for the conventional and SCAMP hoppers, has questionable utility.

Figure 22. Stack panel after 91 kg of WC 844 propellant were initiated in SCAMP hopper

Figure 23. "Vent pipe" of SCAMP hopper after 91 kg of WC 844 propellant were initiated in hopper

2. A program be initiated to design and test effective venting for both the conventional hopper and the SCAMP hopper.

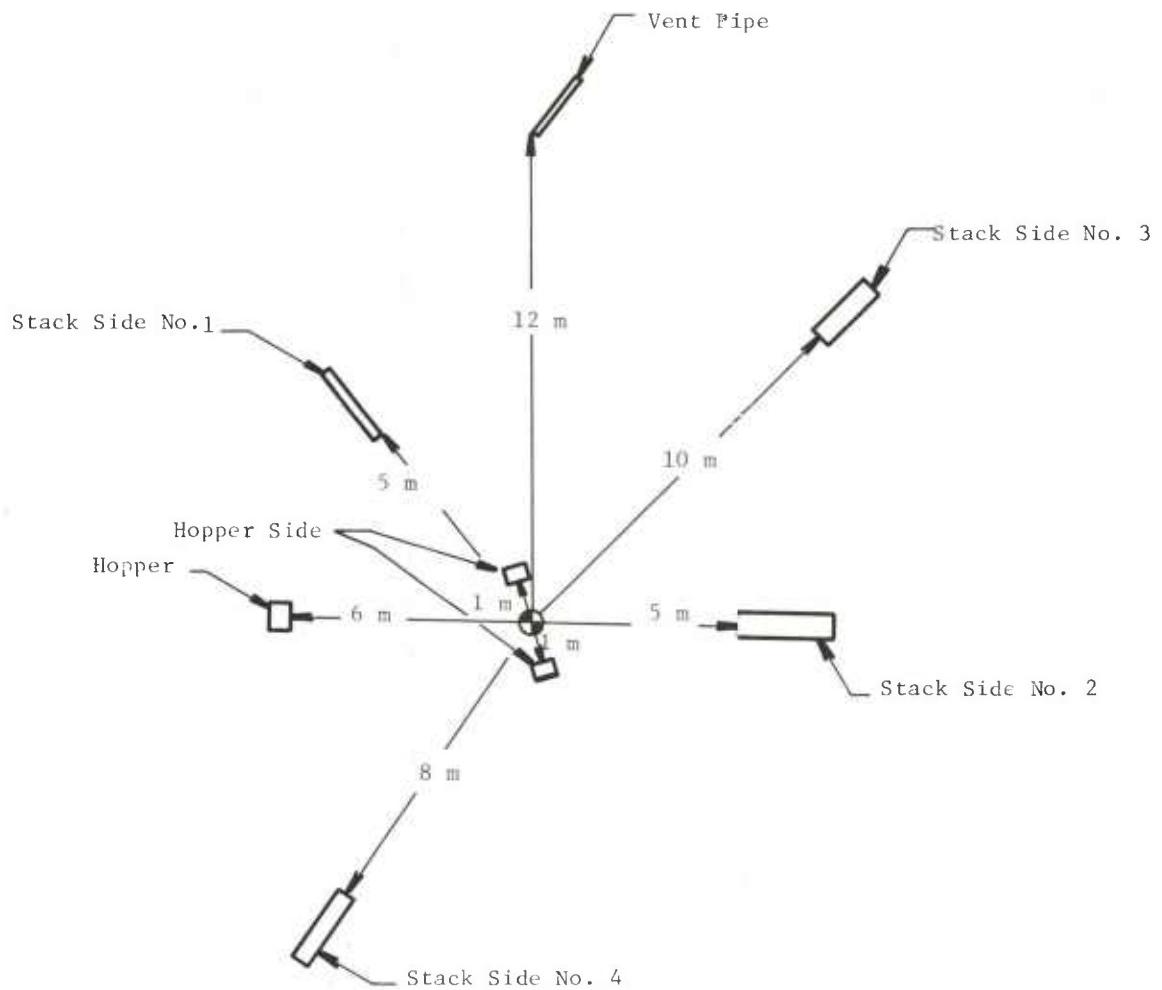
The SCAMP hopper propellant load was reduced to 68 kg as the "minimum acceptable" for process operations. To that end, the 68 kg propellant charge was placed in the hopper and initiated. Figure 24 illustrates the distribution of segments of the hopper following the explosion. Figures 25 through 30 are photographs of the hopper segments after the test. The pressure trace for this test is shown in figure 31. The "peak pressure" is in the order of 37.2 kPa. The trace shows a fairly rapid pressure excursion during the primary impulse followed by several smaller pulsations. Each vertical division represents 11.07 kPa and each horizontal division is 500 ms. Following this, test portions of the hopper were salvaged,

Figure 24. SCAMP hopper debris distribution following test with 68 kg of WC 844 propellant

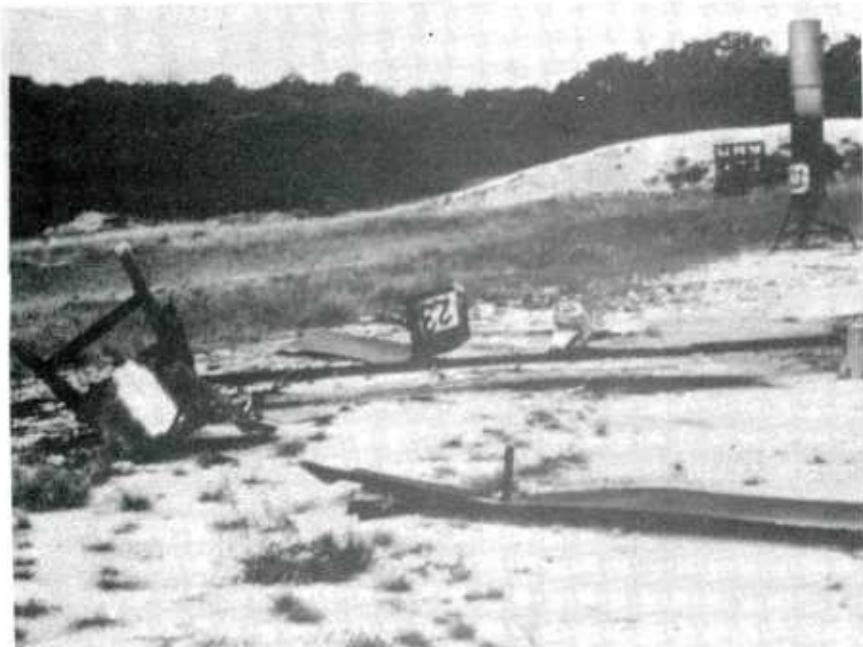
Figure 25. SCAMP hopper debris after initiation of 68 kg of WC 844 propellant (stack panel no. 4 in foreground)

Figure 26. SCAMP hopper base after initiation of 68 kg of WC 844 propellant

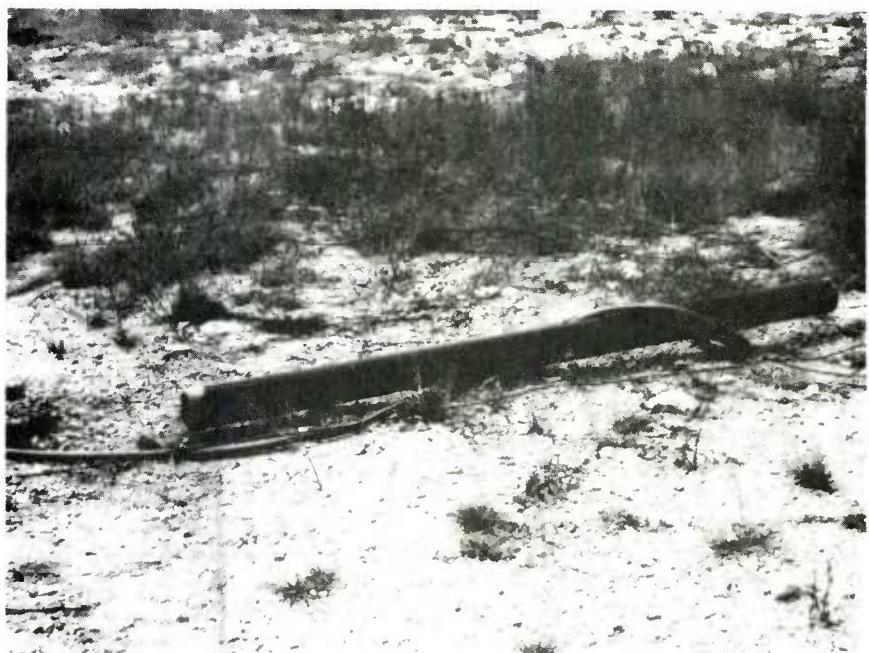
Figure 27. SCAMP hopper "vent pipe" after initiation of 68 kg of WC 844 propellant

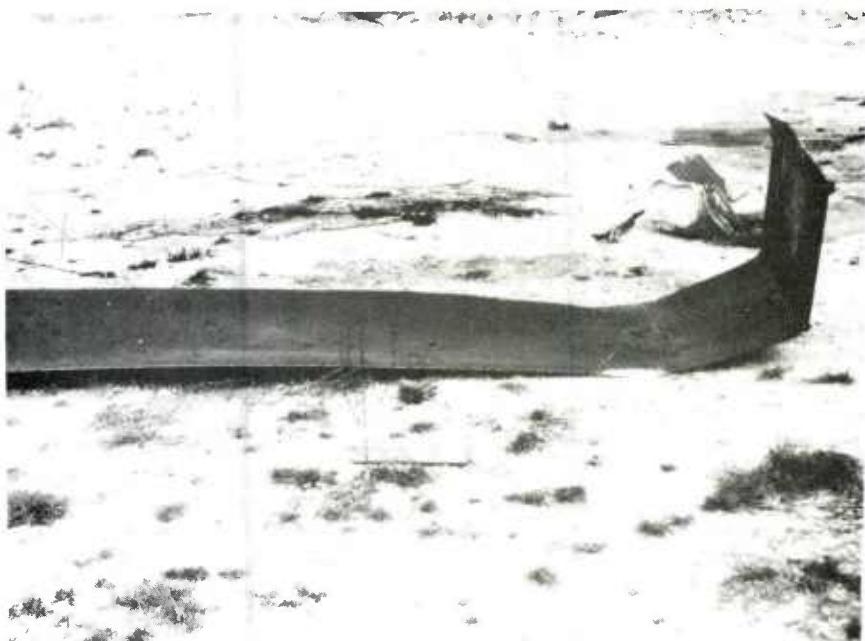
Figure 28. SCAMP hopper stack panel no. 1 after initiation of 68 kg of WC 844 propellant

Figure 29. SCAMP hopper stack panel no. 2 after initiation of 68 kg of WC 844 propellant

Figure 30. SCAMP hopper stack panel no. 3 after initiation of 68 kg of WC 844 propellant
